RESILIENCE OF A CROSS-BORDER NATIONAL MOUNTAIN ROAD RN134 IN THE FACE OF BAD WEATHER

G. LACASSY, JM. COUDESFEYTES, M. RACHET & JF. MOULIN
 Direction Interdépartementale des Routes Atlantique (DIRA)
 Ministry of Transport, France

A CLASSIC MOUNTAIN ROAD WITH SNOW, AVALANCHES, LANDSLIDES, ROCKFALLS AND FLOODS!

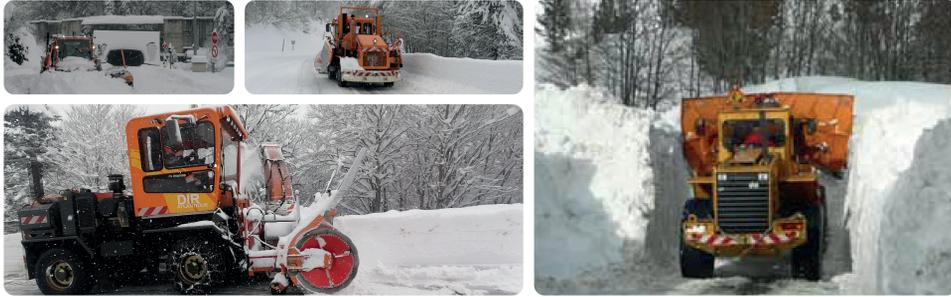
Snow removal

Avalanche removal

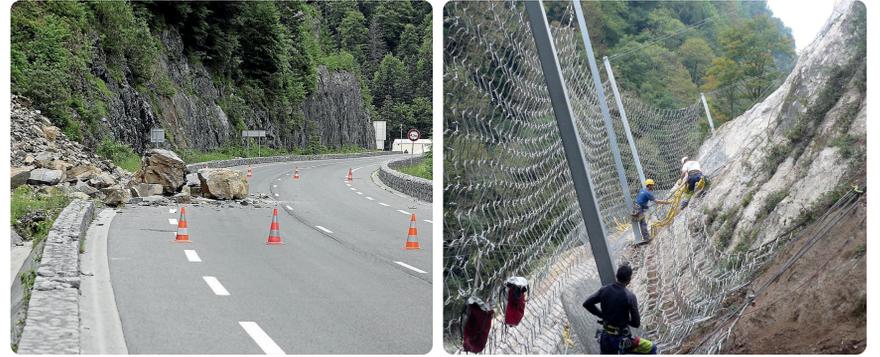
Rockfalls

Nets

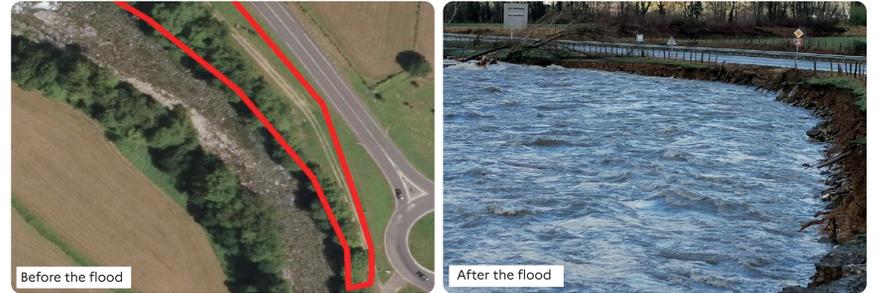
Before the flood

After the flood

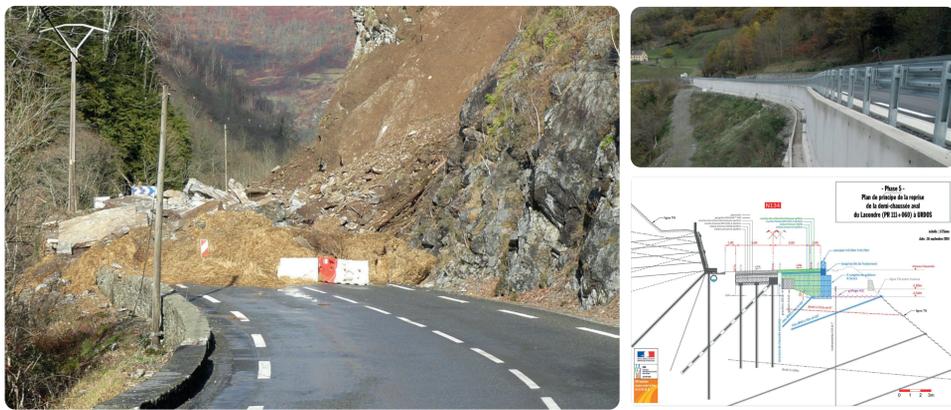
Landslides and repairs

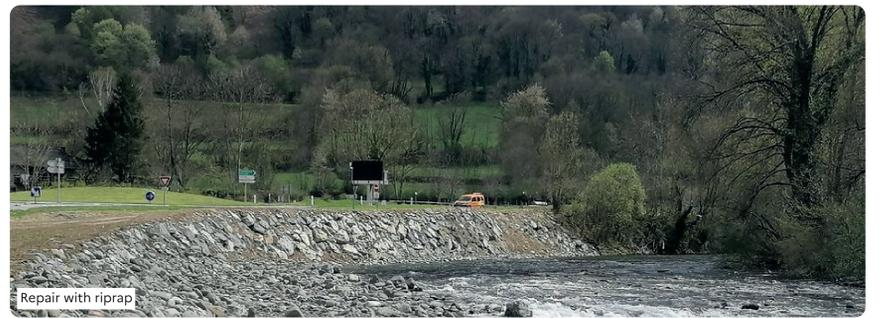
Repair with riprap

Road embankments washed away by flooding of the Gave d'Aspe river

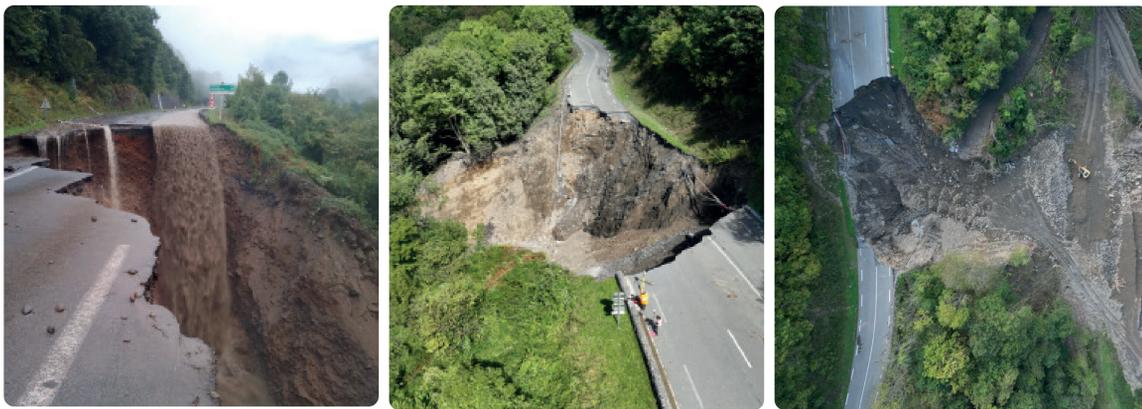
Main event : aerial view of the breach

Others events : rockfill removed, slope movement, blocked hydraulic structures or log jams

60 sites affected along a 30-kilometer stretch of the RN134

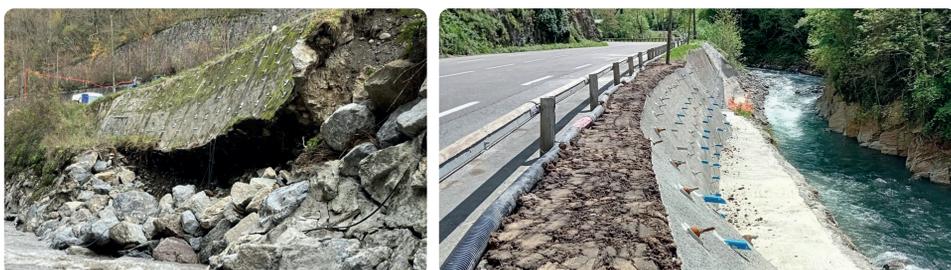
Suspended nailed wall

Reinforcement work carried out

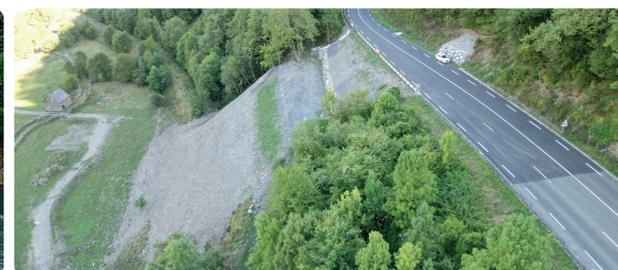
Gap filled, roadworks completed in 3 months - 27 000 m³
